## Powersave Test Cases

Goal: Test and verify powersave mode on a station using various methods.

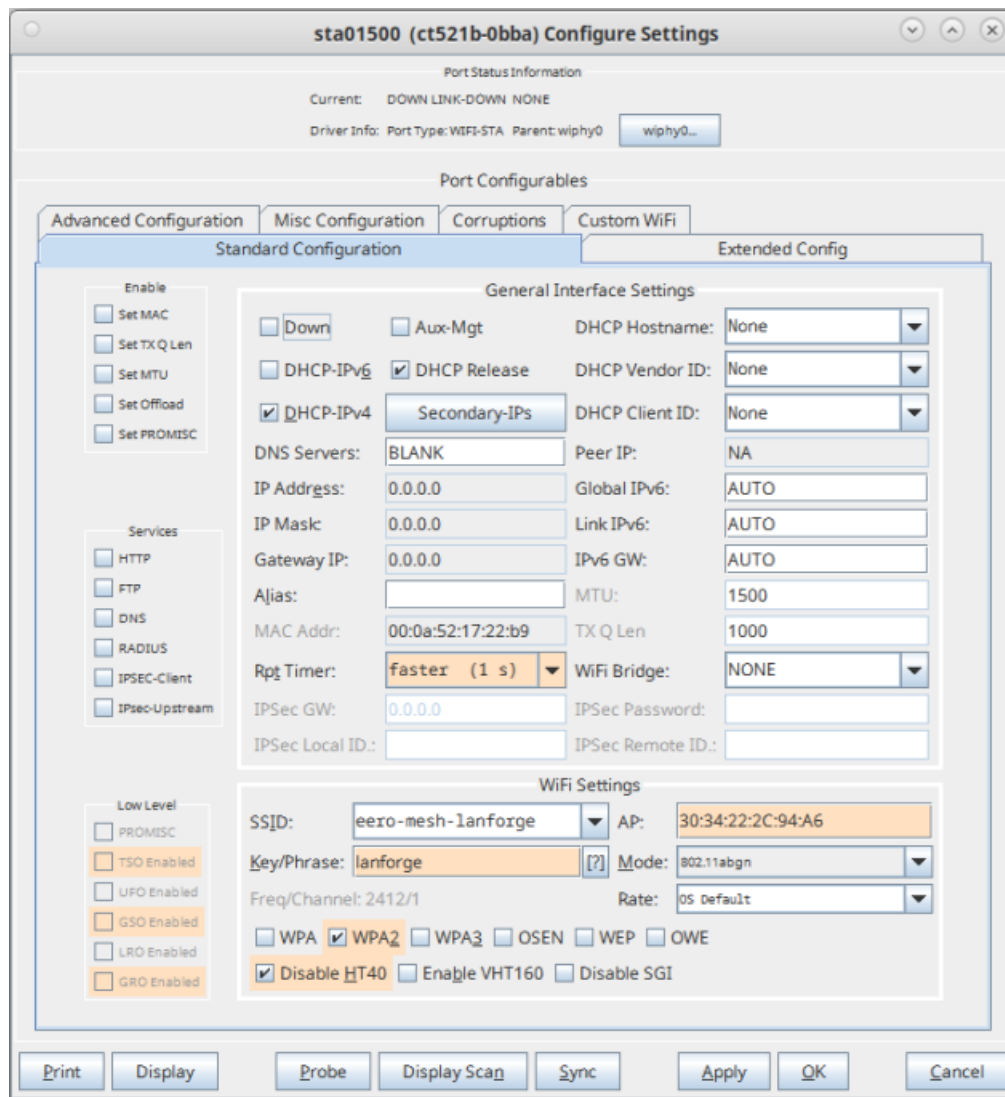
- Configure station for something easy to sniff (20Mhz a/b/g/n) by clicking the *Disable HT40* button in the *Standard Configuration* tab. Then click *Apply* and *OK* to close the *Configure Settings* window for the station.

- Set up mcast traffic between upstream port sending to station with parameters of 9kbps *Min Speed*, 128 Kbps *Max Speed* and Default *Pkt Size* using the following cookbook link:  
<http://www.candelatech.com/cookbook.php?vol=wifire&book=WiFi+Station+Multicast>.
- Double-click on the created station in the *Port Mgr* tab. Enable *Powersave* on LANforge station (in the *Misc Configuration* tab)
